Transport
Canada

TP 185E
Issue 3/2005

AVIATION SAFETY LETTER

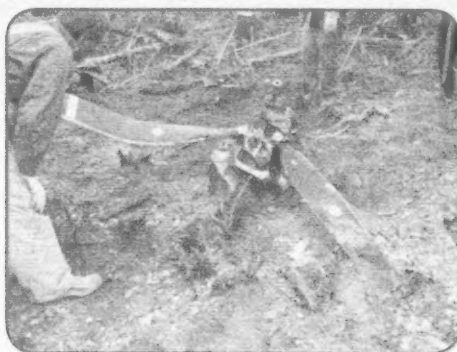
TSB investigator analysing the Cessna Caravan's propeller.

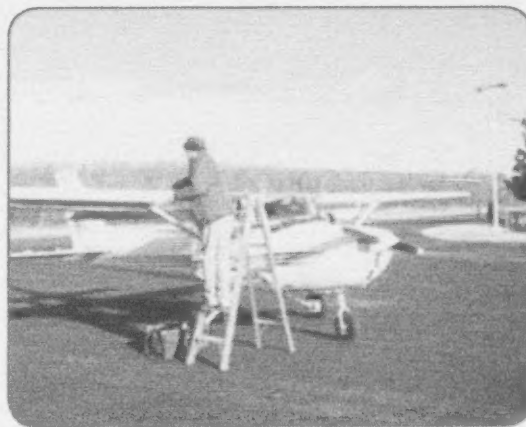
Pilot removing frost manually on small aircraft.

Manual methods—Reducing the amount of de-icing fluid used can have a positive impact on both the cost and the environment. Manual methods of snow removal should be used whenever possible, as long as safety is not compromised. There are a wide variety of devices available to assist in the removal of frozen contaminants from aircraft. Factors such as temperature, amount of contamination, wind conditions, and contaminant location must be taken into account when choosing the method.

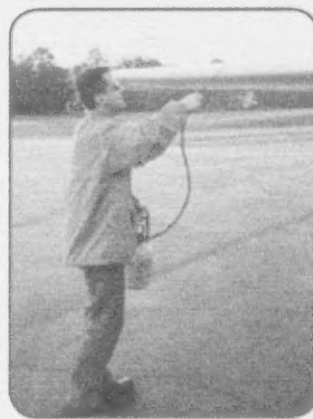
Small hand-sprayers can be used effectively.

Hand sprayers—Extreme operational conditions often require specific solutions. Winter operations in the Canadian North pose their own problems due to the extremes in both weather and temperature. It has been noted that a number of air operators carry Type I fluids with them in the aircraft from station to station so that it is available. The containers in which the fluid is kept resemble the common garden insecticide sprayer. The fluid in this circumstance would appear to be kept at room temperature.

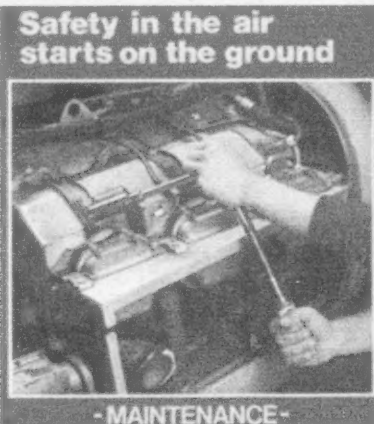
Slippage marks are also commonly used in tire assembly and build-up to reduce the possibility of tire and tube failure due to slippage. The tire is marked and indexed with the wheel rim, which provides for an easy visual indication of any tire slippage.

Not only does the application of torque paint (slippage marks) make good sense, most manufacturers require it. Operators and maintainers should ensure that torque paint (slippage marks) is applied correctly and is inspected at the required intervals to help ensure that they provide the additional safety that was intended. Δ
